Finishing and Restoring Wood and Structures

Yellow-Poplar Lumber for Exterior Architectural Applications in New Construction and for Historical Restoration

Daniel L. Cassens, Professor of Wood Products and Extension Specialist, Purdue University

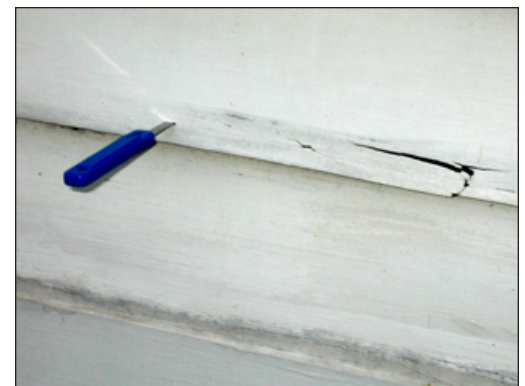
Figure 1. The decay shown in this yellow-poplar siding on a new construction started about six years after installation.

Yellow-poplar (also called tulip poplar and American tulip) has shown a resurgence in popularity in recent years due to its cost and greater abundance. Unfortunately, decay in yellow-poplar lumber can be a serious issue in just a few years (Figures 1 and 2). This publication will discuss the positive and negative attributes of yellow-poplar as an exterior millwork product and describe ongoing efforts to improve its durability.

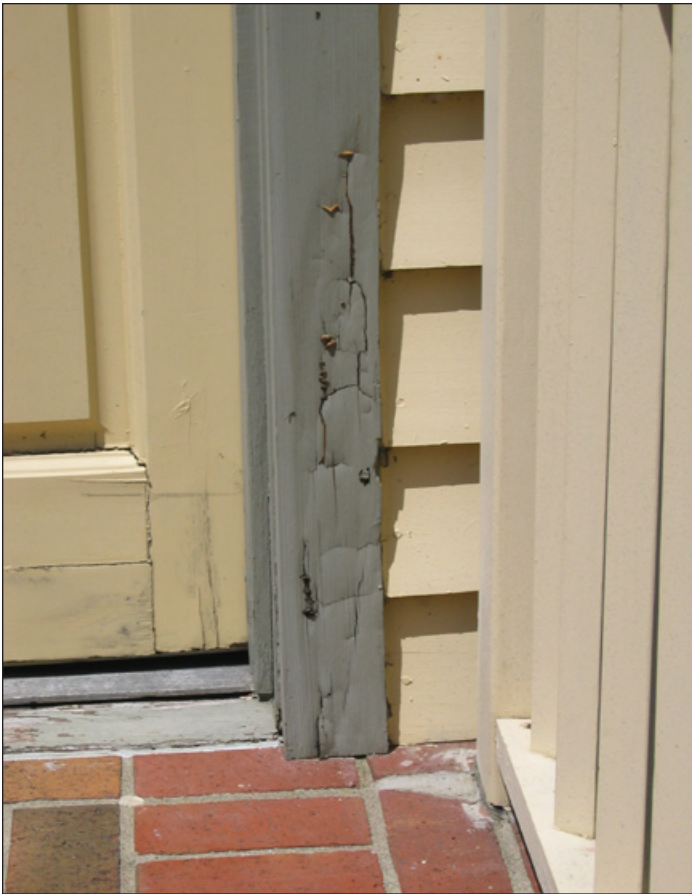
Figure 2. This residence in Historic New Harmony, Indiana, has deteriorating yellow-poplar.

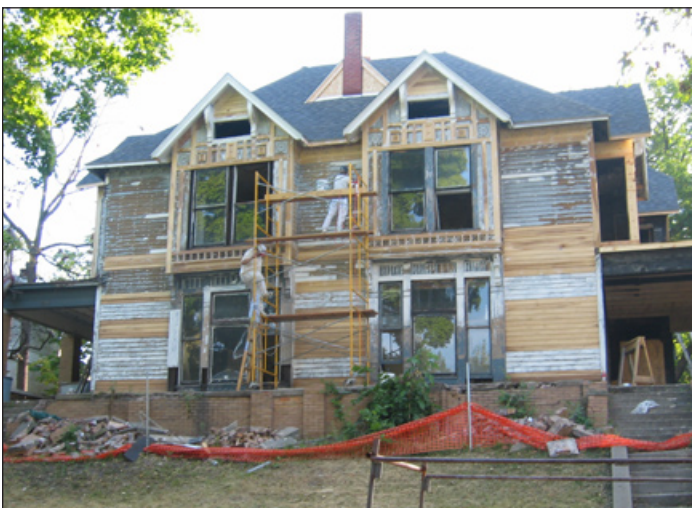
Figure 3. This 1880s Midwestern house originally used yellow-poplar for siding and architectural adornment. Restorers replaced about one-third of the siding with a mix of yellow-poplar sapwood and heartwood.

applications (Figure 3). As yellow-poplar was depleted in these areas, the timber industry moved west and south for new sources of lumber. As a result, western and southern pine species replaced yellow-poplar.

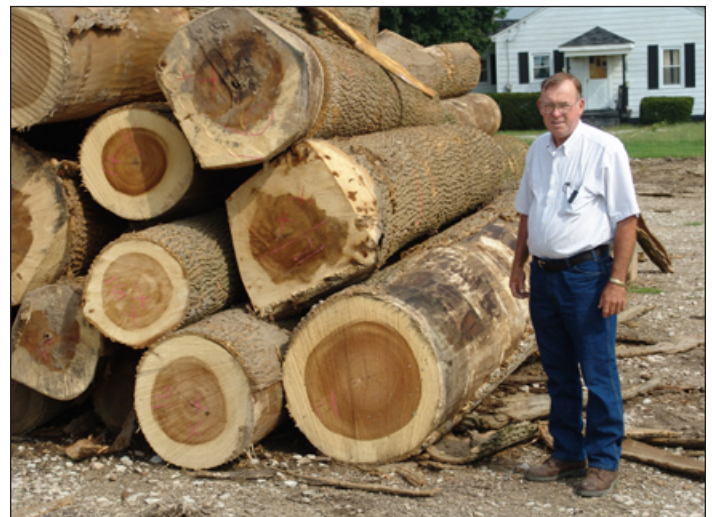
Figure 4. These yellow-poplar logs show a wide sapwood band and brown heartwood. Logs of this excellent size and quality are commonly available.

Yellow-poplar is an abundant, fast growing, fast drying, easily worked, relatively low-valued, and excellent hardwood timber species (Figure 4). It ranges in much of the eastern United States (Figure 5), and constitutes about 9 percent of the sawtimber in the eastern hardwood forest (Smith et al, 1997). Only the oaks exceed yellow-poplar in available hardwood sawtimber volume.

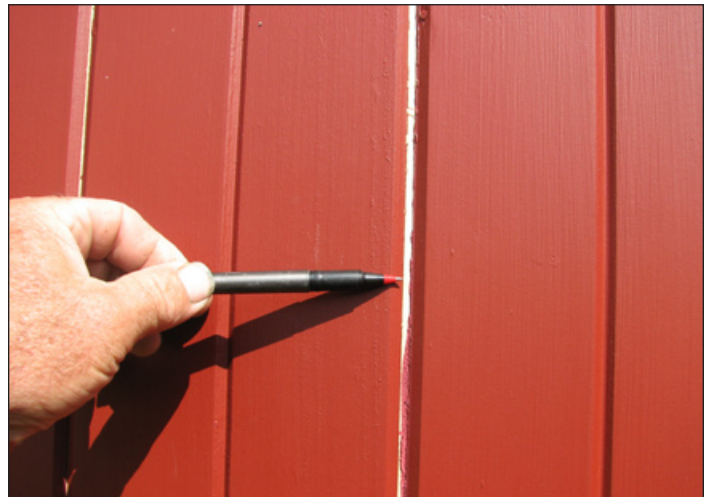
Figure 6. This tongue and groove yellow-poplar barn siding was air dried well before it was installed (to about 15 percent moisture content), and accepted paint well. Before installation, a water repellent preservative was applied to all sides, edges, and ends of boards. On this fully exposed west-facing wall, the lumber dried to about 8 percent moisture content in the summer, shrunk, and exposed the unpainted tongue. A north-facing wall did not experience the same problem.

Yellow-poplar wood is intermediate in shrinkage. In use, the wood is somewhat unstable (Figure 6). Therefore, it should be conditioned to the average moisture content it will experience in use and fastened securely. Standard ring shank siding nails and the use of power driven screws will help alleviate stability problems.

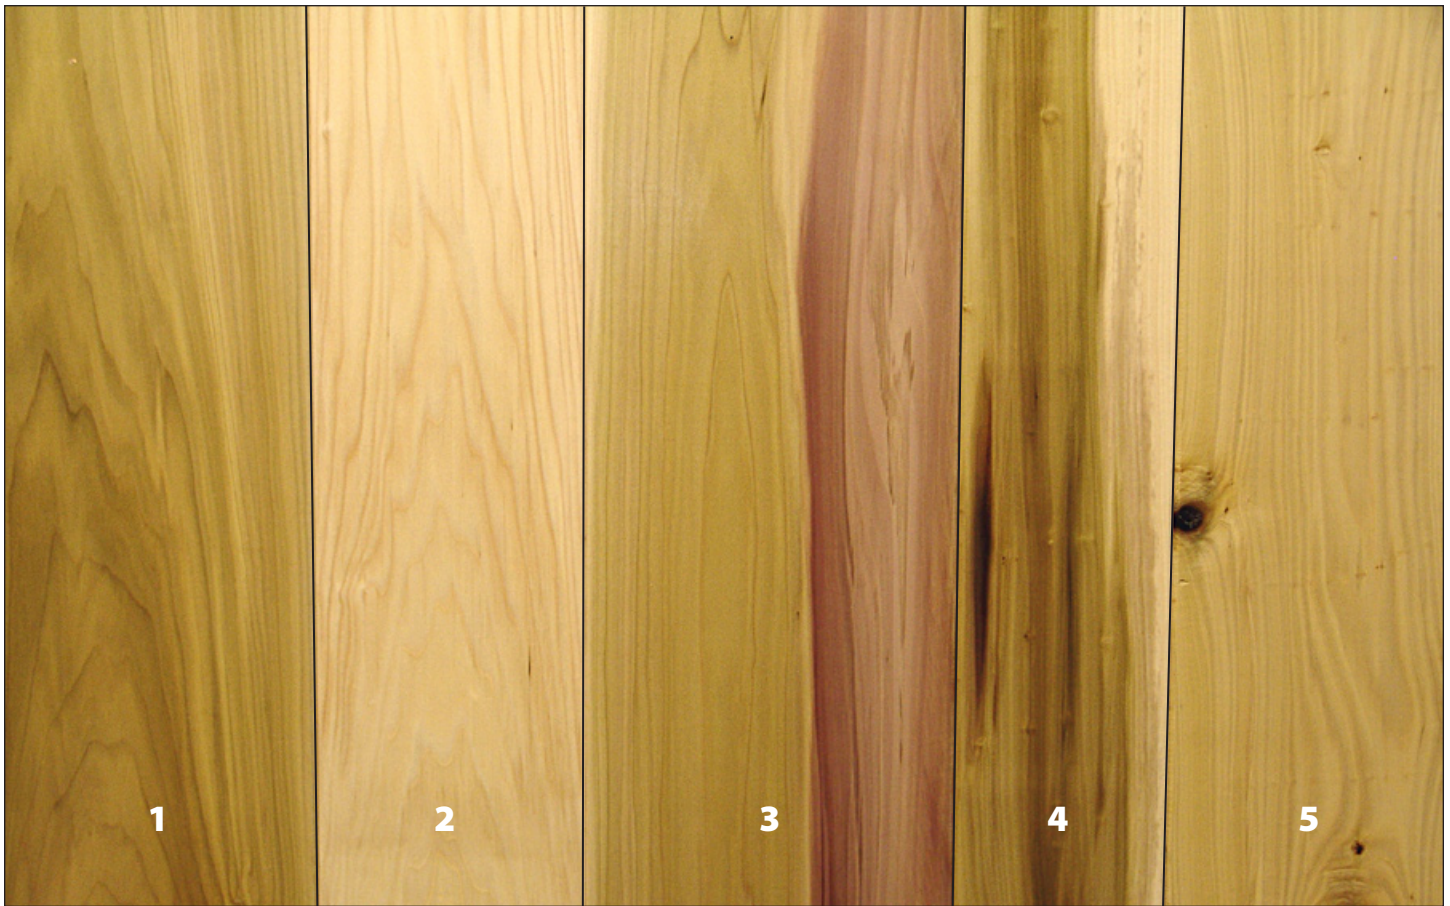
The yellow-poplar boards shown here provide a range of common characteristics.

Board 1 shows the wide, clear heartwood typical of high-grade yellow-poplar. The growth rings are faintly visible, but there are no discernible pores visible to the naked eye. The color of the heartwood will vary from this relatively dark green to a lighter, almost yellow color in some boards. Small burls are present in the bottom right corner of this piece.

Board 2 is all white sapwood. Heartwood and sapwood are often mixed in the same board, making it difficult to obtain a uniform natural color in a finished product. The sapwood tends to darken to a very light brown, and the greenish heartwood changes to a dark brown over an extended period.

Sapwood also tends to turn gray due to oxidation stain. This piece shows evidence of two very light sticker marks. Stickers are

strips of lumber used to separate the different courses/layers of boards during drying. In white woods, stain can often develop under these stickers. In this case, the contrast appears to be due to weight and crushing of the wood.

Board 3 shows a purplish color, called mineral stain on the right side. In some boards this color will be almost black. With time, the color changes to a dark brown. This stain is probably the result of wounding to the tree.

Board 4 shows mixed heartwood and sapwood and numerous grain swirls. The grain swirls are probably the result of shallow bird peck in the cambium. Some sap stain appears along the right edge.

Board 5 shows both open and tight knots and grain swirls across the width of the board.

For examples of yellow-poplar boards and staining, see Examples of Yellow-poplar Lumber on page 6.
